Repairing broken rear window defroster tabs and missing defroster pulled off by tab.

Bulletin 116

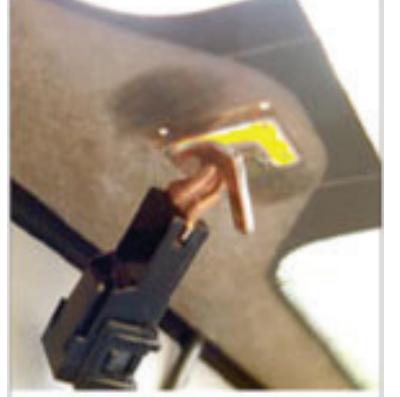
When a metal tab separates from the defroster it can pull away some of the defroster coating from the glass. Sometimes the tab breaks leaving the base of the tab still attached to the defroster.

Defroster tab separation

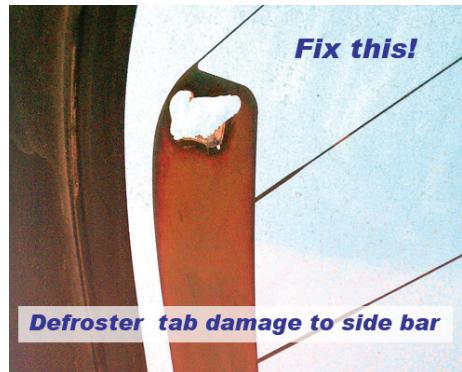
Badly damaged defroster occurred when the tab pulled some of the defroster material away from the glass.

It is common for some of the defroster coating to be pulled off with the tab as it separates from the defroster. In these cases the damaged area can be repaired and the tab re-attached using the 2000 Tab Bonding Kit's highly conductive silver adhesive.

The first step is to create a small pad of conductive coating over the damaged area on the defroster.

Clean up and smooth the damaged area. A screw driver can be used to scrape the area and then it can be sanded for a relatively smooth surface. The goal is a good conductive bond between the defroster and the replacement tab.

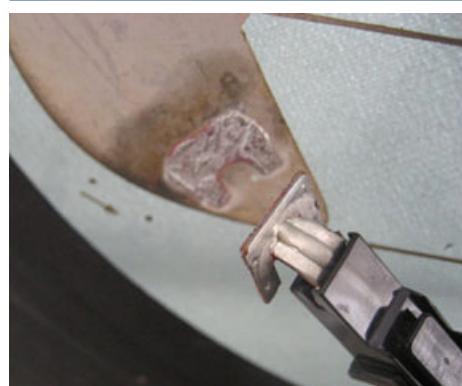
Damaged defroster pad

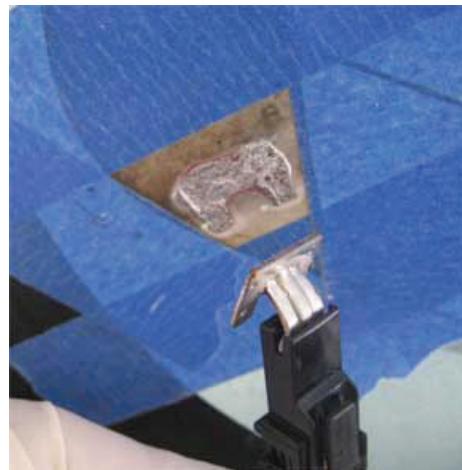
Mask off damaged area

Using masking tape mask off an area that covers the damaged area on

the defroster and incorporates some of the undamaged defroster. Add a second layer of tape on top of the original masking tape so there are TWO tape thicknesses around the bonding site.

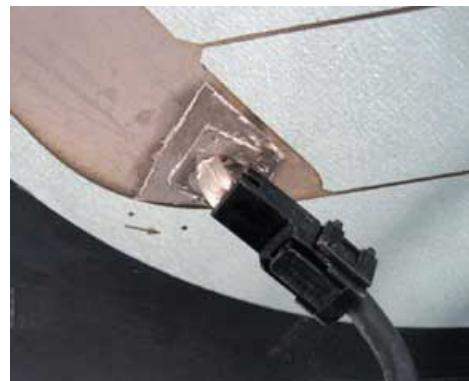
Damage repaired

Make sure the bonding pad is smooth and even and then dip the tab base in the adhesive and position it on top of the bonding area while wet. Be sure to check the orientation of the tab so it can be re-connected to the connector when the time comes.

Next, hold the connector in place (light pressure with screw driver or pliers) and, using a hair dryer, heat lamp or other heater, warm up the bond site for several minutes until the adhesive starts to lock down. Then keep the area warm (100-130°F) for at least 30 minutes and you're back on the road with a working defroster.

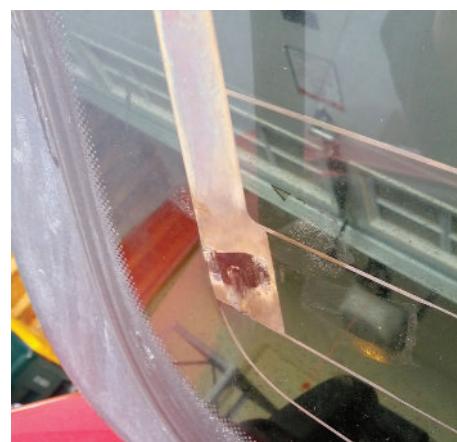
More defroster damage

If the tab base is still on the defroster there are two options. a) If there is enough defroster material around the tab it is appropriate to bond the new tab to the defroster close by the broken tab base. b) The other option is to remove the tab base and bond the replacement tab in its place.

There are several techniques for removing the tab base. Since most tabs are soldered in place it is relatively easy to re-flow the solder and remove the tab using a soldering iron. Be careful not to break the glass when soldering or applying spot heat to rear windows. A wet towel on the outside of the window can help reduce overheating.

A screw driver blade, pliers or a Dremel tool can be used to remove the tab base. Do not worry about causing additional damage to the defroster as it can be repaired using the technique shown above.

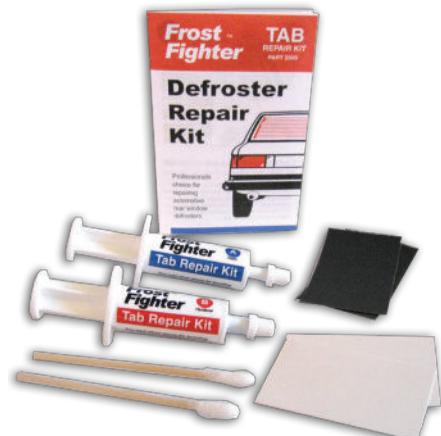
2000 Tab Bonding Kit

The 2000 Tab Bonding kit is a highly conductive two-part silver adhesive that cures quickly, bonds aggressively and forms the electrical and structural connection to the defroster in one simple operation.

The adhesive's high silver loading provides maximum electrical conductivity ideal for the high amperage bonds needed in defroster tab repair.
