### Repairing broken rear window defroster tabs and missing defroster pulled off by tab.

#### Repair missing defroster pulled off by tab

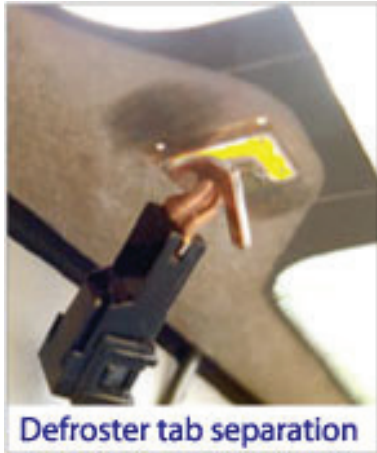
Defroster tab separation

When a metal tab separates from the defroster it can pull away some of the defroster coating from the glass. Sometimes the tab breaks leaving the base of the tab still attached to the defroster.

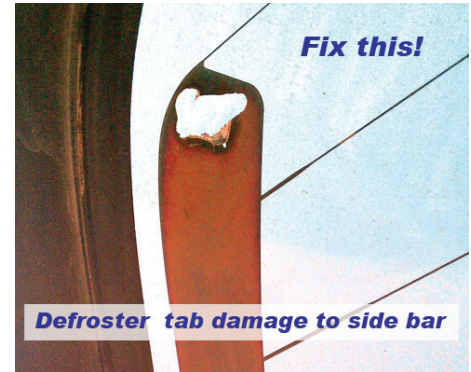
Badly damaged defroster occurred when the tab pulled some of the defroster material away from the glass.

It is common for some of the defroster coating to be pulled off with the tab as it separates from the defroster. In these cases the damaged area can be repaired and the tab re-attached using the 2000 Tab Bonding Kit's highly conductive silver adhesive.

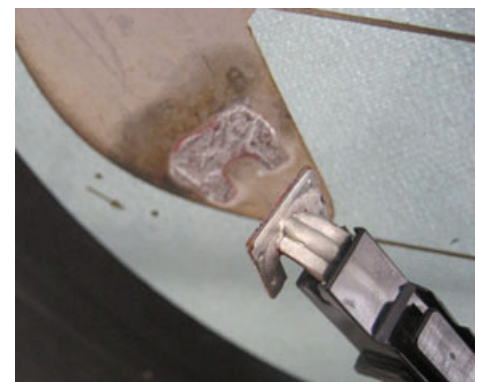
Damaged defroster pad

The first step is to create a small pad of conductive coating over the damaged area on the defroster.

Clean up and smooth the damaged area. A screw driver can be used to scrape the area and then it can be sandpapered for a relatively smooth surface. The goal is a good conductive bond between the defroster and the replacement tab.

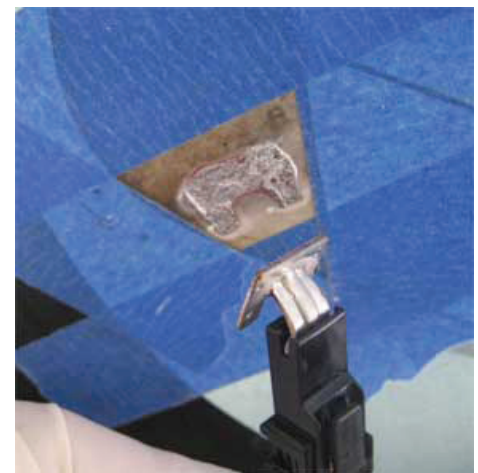
Mask off damaged area

Using masking tape mask off an area that covers the damaged area on

the defroster and incorporates some of the undamaged defroster. Add a second layer of tape on top of the original making tape so there are TWO tape thicknesses around the bonding site.

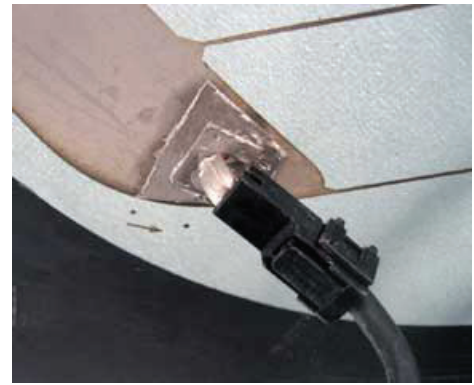
Damage repaired

Make sure the bonding pad is smooth and even and then dip the tab base in the adhesive and position it on top of the bonding area while wet. Be sure to check the orientation of the tab so it can be re-reconnected to the connector when the time comes.

Next, hold the connector in place (light pressure with screw driver or pliers) and, using a hair dryer, heat lamp or other heater, warm up the bond site for several minutes until the adhesive starts to lock down. Then keep the area warm (100-130°F) for at least 30 minutes and you're back on the road with a working defroster.

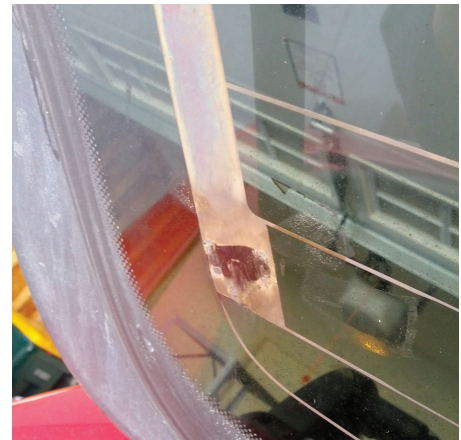
More defroster damage

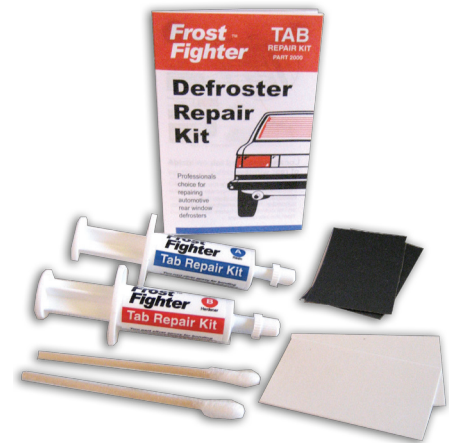
2000 Tab Bonding Kit

The 2000 Tab Bonding kit is a highly conductive two-part silver adhesive that cures quickly, bonds aggressively and forms the electrical and structural connection to the defroster in one simple operation.

The adhesive's high silver loading provides maximum electrical conductivity ideal for the high amperage bonds needed in defroster tab repair.
