**NUMBER:** 08-037-19 REV. B

Rear Window Defroster Inoperable

This bulletin involves inspecting and possibly repairing the terminal of the rear defroster circuit.

2017 - 2018	(JK)	Jeep Wrangler
2018 - Current	(JL)	Jeep Wrangler

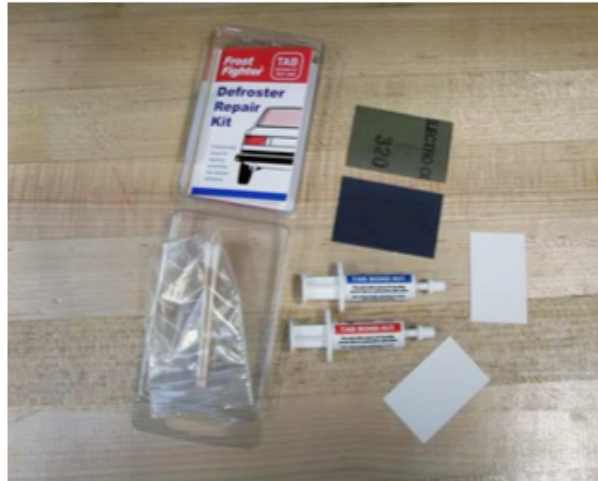
For these vehicles it is recommended to use a Frost Fighter 2000® Defroster Repair Kit (Fig. 1) and if necessary Mopar #68428688AA, Tab.

Fig. 1  
Frost Fighter 2000 Defroster Repair Kit

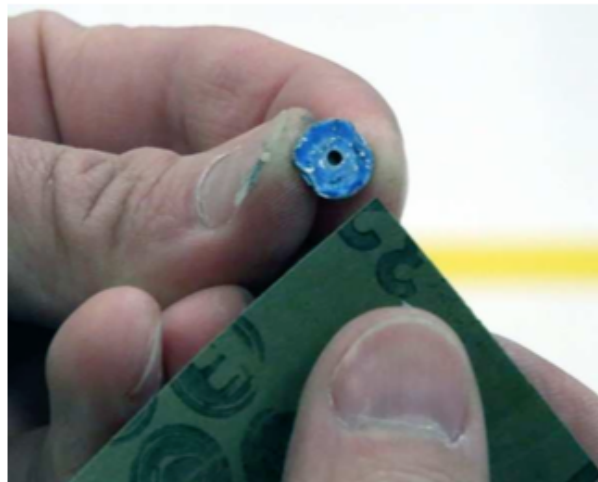
**NOTE: The flux that is pre-coated on the tab will cause adhesion issues with the epoxy. Remove before applying epoxy to contact point (Fig. 2) .**

Fig. 2  
Rear Defroster Tab

For detailed repair procedure. Refer to the detailed service procedures available in DealerConnect> Service Library under: Service Info> 08 - Electrical / 8G - Heated/Cooled Systems / Heated Glass / Grid, Defogger / Standard Procedure> grid line and terminal repair.
